River Bank Erosion Induced Human Displacement and Its Consequences

Abstract

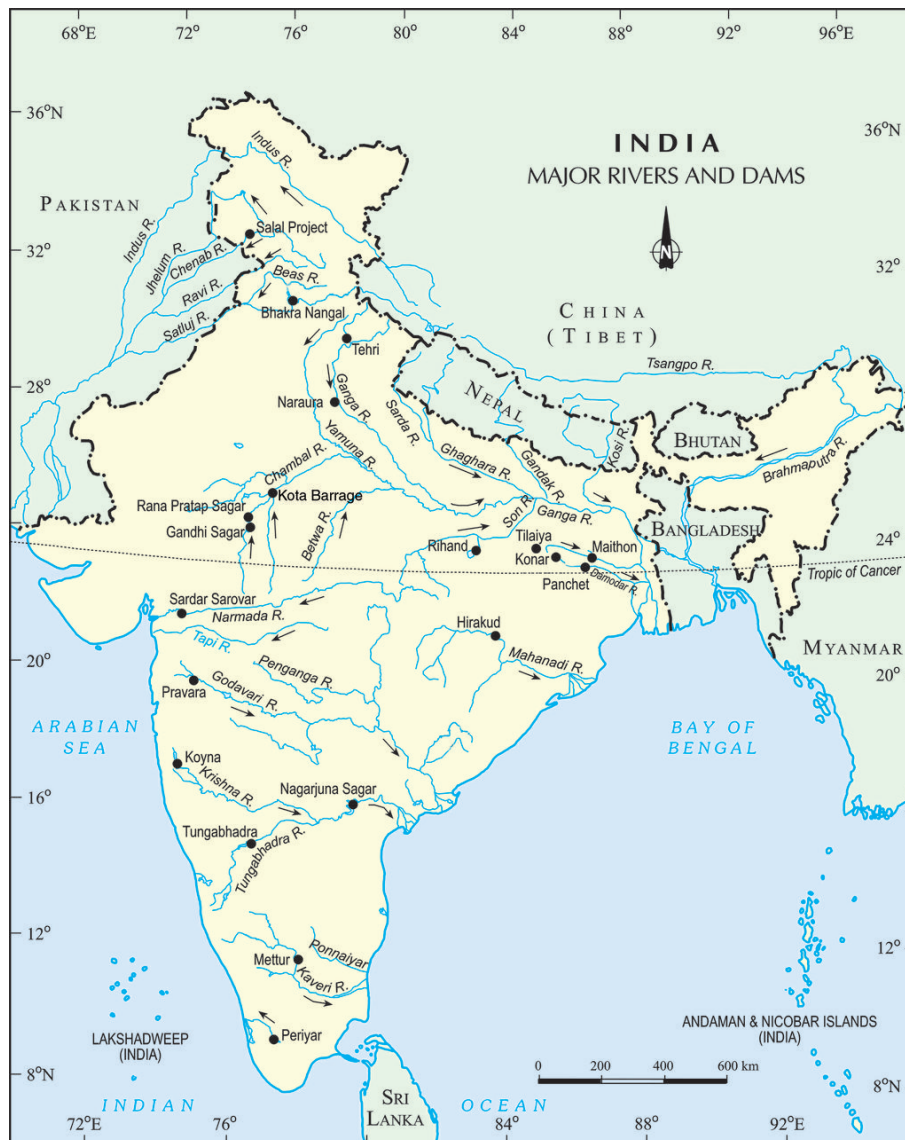
Figure 4: Rivers in India. (Source: <http://nroer.in/gstudio/resources/imagecollection/colln/35270/>)

The rivers in India (Figure 4) can be broadly divided into four regions related to erosion problems.

The River Ganges and its numerous tributaries cover the states of Uttaranchal, Uttar Pradesh, Jharkhand, Bihar, South and Central parts of West Bengal, parts of Haryana, Himachal Pradesh, Rajasthan, Madhya Pradesh and Delhi (Figure 4). Even though the Ganges is a long river carrying huge discharges of up to 70 000 m³/s, the erosion problems are confined to relatively few places. The flood and erosion problems are serious in the lower Ganges region, particularly in West Bengal.

River bank erosion is occurring in other regions too, but not to the extent as in Brahmaputra region or lower Ganges region. One example is the river erosion in Uttar Pradesh of the River Ghaghara, which flows from Nepal into Northern India (Figure 4). The River Ghaghara is a major left bank tributary of the River Ganges. It has changed its course since 1995 causing vast erosion of the river bank, especially after 1998 (International Fact Finding Mission, 2005). Due to this erosion more than 5000 thousand households have lost their houses and means of livelihood. Affected households did not get any compensation for their cultivable land, but got offered a relief package of a small amount of money and a housing plot (not sufficient for cultivation) in the same district.

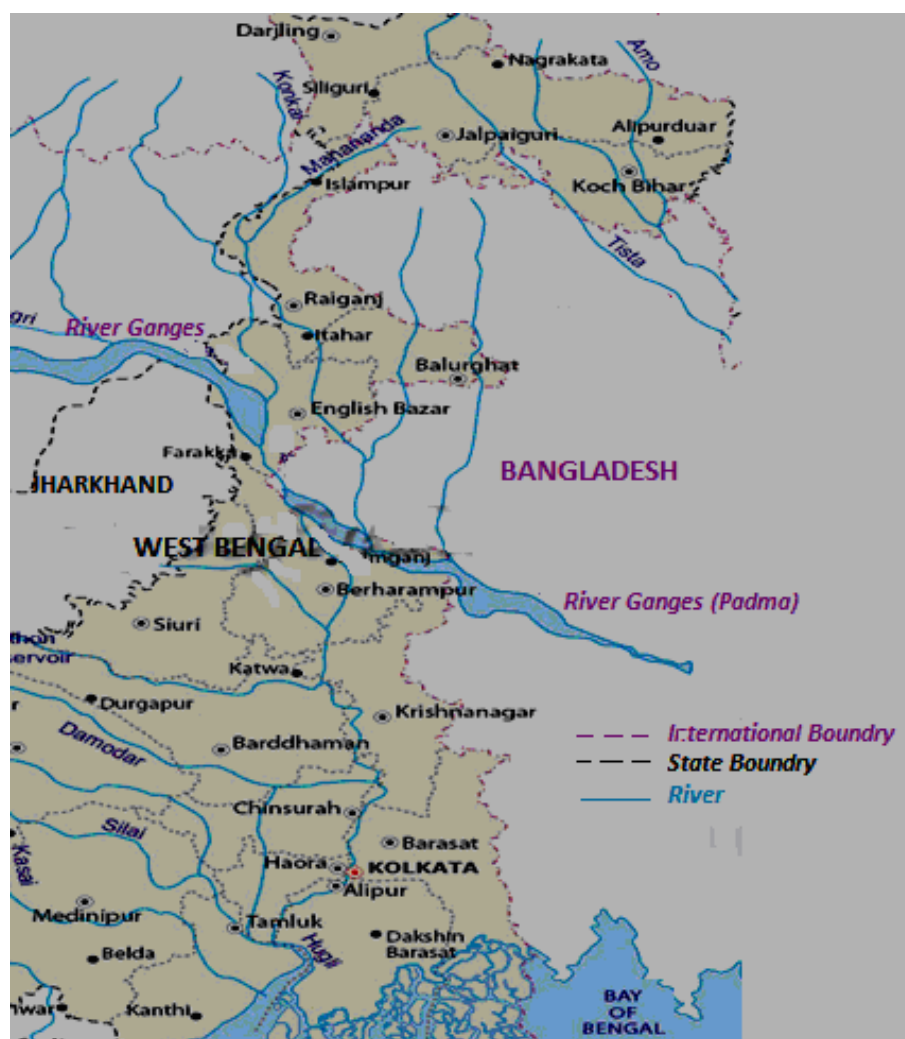
Figure 6: Course of river Ganga (Ganges) in West Bengal.

The River Ganges enters West Bengal near Rajmahal in Jharkhand state and then it flows in a South-easterly direction within West Bengal (Figure 6). After flowing through Malda district it divides into two branches near North of Dhulian in the Murshidabad district. One branch enters Bangladesh as the Padma, while the other flows through West Bengal as the Bhagirathi River and Hooghly River in Southern direction. The Bhagirathi is the main river in West Bengal, which flows past the Murshidabad, Nadia, Burdwan and Hooghly districts and contributes to a dominant irreparable loss of land each year.
